NBSIR 82-2510

Quality of Inspections Utilizing Infrared Technology on Weatherization Retrofit Installations

November 1982

**QUALITY OF INSPECTIONS UTILIZING
INFRARED TECHNOLOGY ON
WEATHERIZATION RETROFIT
INSTALLATIONS**

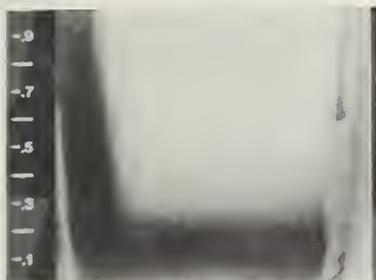
1-1
Solar Effect on
'hollow' front door.
(by contractor #3)

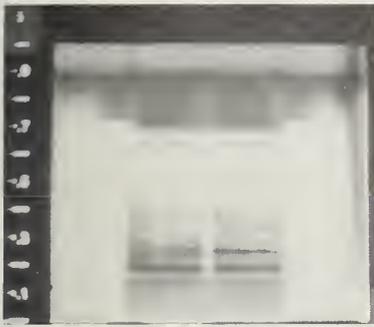
2-1
E wall of
living room.
(by NBS)

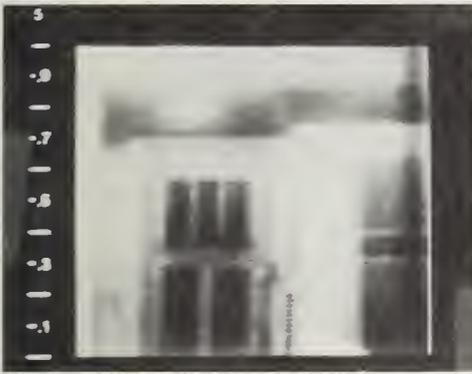
3-1
N wall of
living room.
(by NBS)

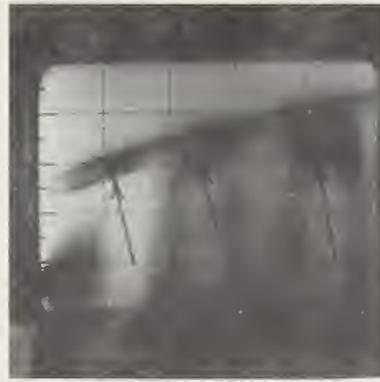
3-2
E wall of
living room.
(by contractor #2)

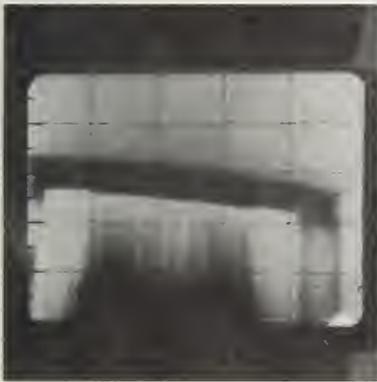
3-3
E wall of
dining room.
(by contractor #2)

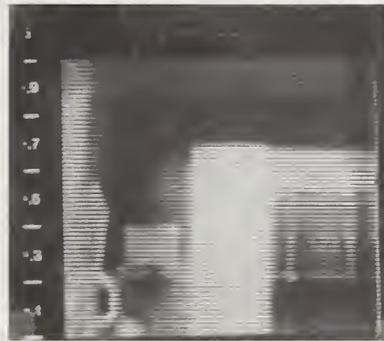
3-4
NE corner on E
of dining room.
(by NBS)

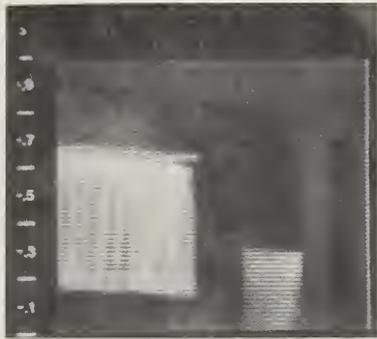
3-8
SW corner of SW bedroom.
(Scanned at overcast
by NBS)

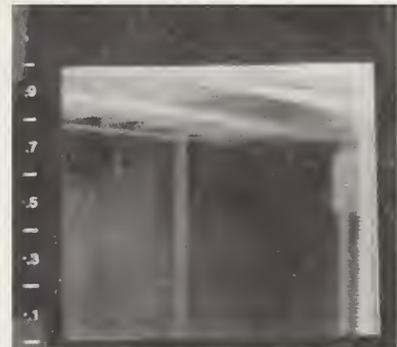
3-12
NE corner of
basement.
(by NBS)

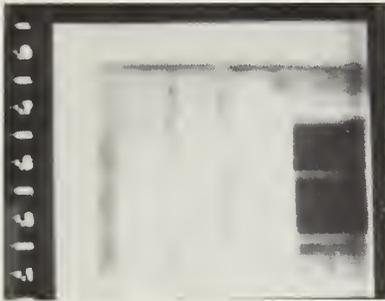
4-1
NW corner on N of living room.
(Different density levels of
insulation by NBS)

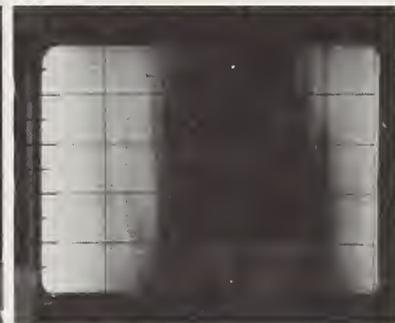
4-5
Infiltration around &
underneath side door.
(by contractor #2)

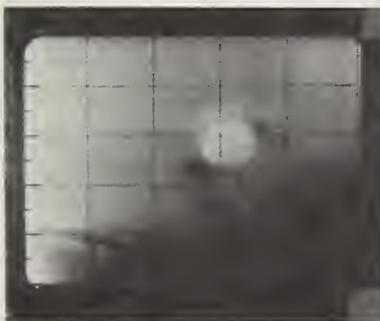
4-6
Problems at
kitchen ceiling.
(by contractor #2)

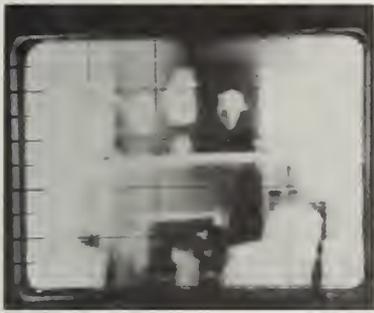
5-1
E wall of
living room.
(by contractor #2)

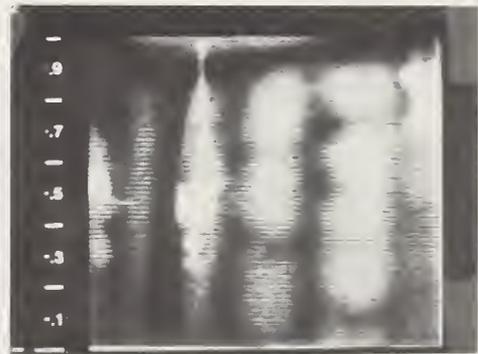
5-6
E wall of
NE bedroom.
(by NBS)

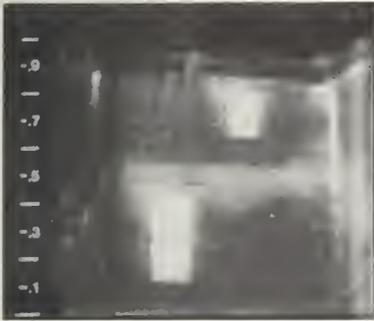
6-1
W side of kitchen
& N bedroom.
(exterior by NBS)

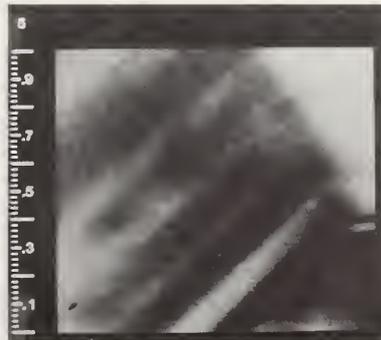
6-8
W pitched ceiling
of N bedroom.
(by contractor #4)

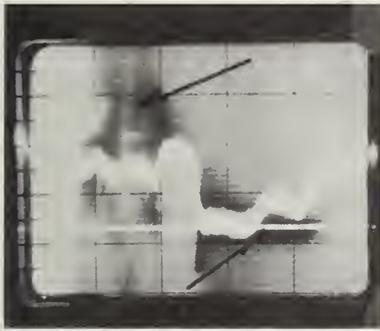
6-9
NE corner on E
of bathroom.
(by contractor #2)

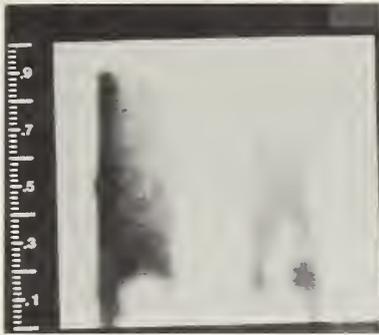
7-1
SW on W of
living room.
(by contractor #4)

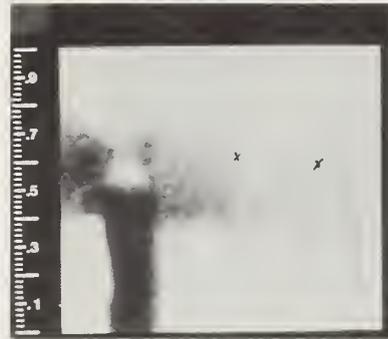
7-2
NW on W of
living room.
(by contractor #4)

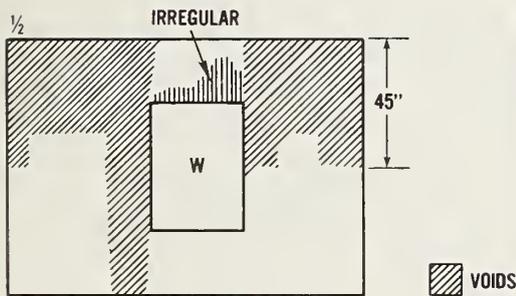
7-3
W wall of
dining room.
(by LRIS)

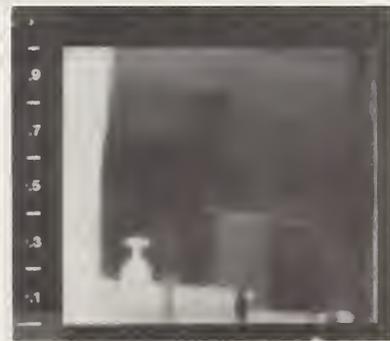
7-7
Ceiling of
den/kitchen
(by NBS)

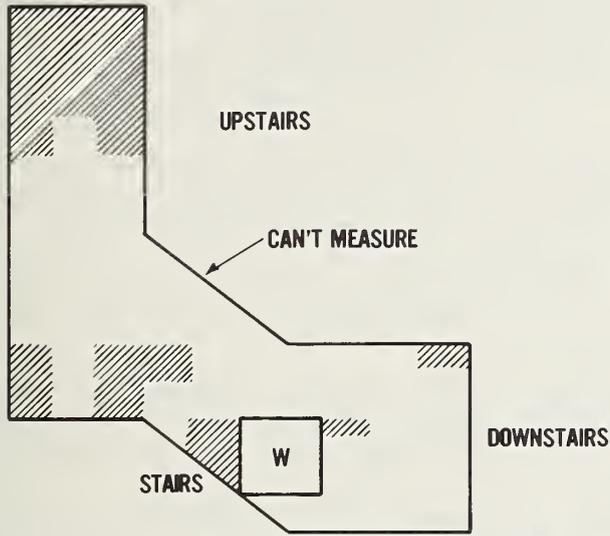
7-8
W wall of stairway.
(by LRIS)

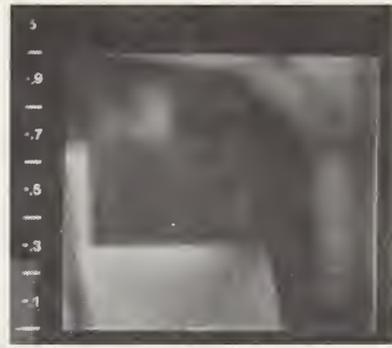
7-9
E wall of
SE bedroom.
(by NBS)

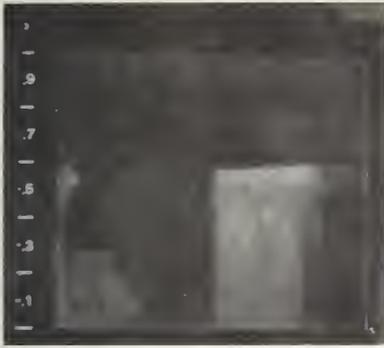
8-1
NE on E wall
of dining room.
(by NBS)

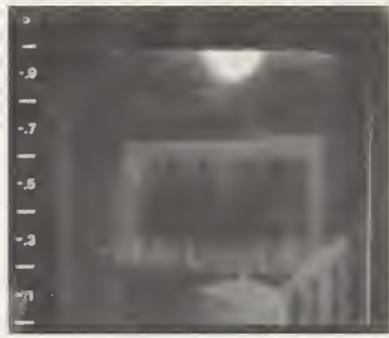
8-3
Above window &
at bottom of stairs
on W of living room.
(by NBS)

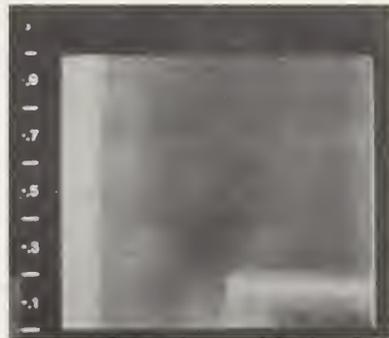
8-6
Above window on
W of stairway
upstairs.
(by NBS)

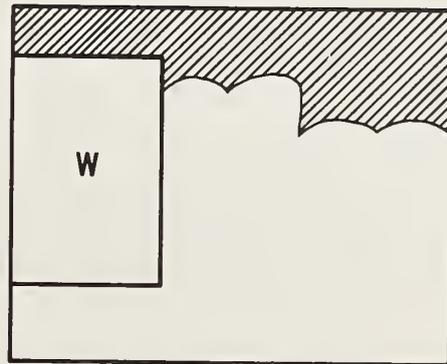
8-8
E wall of
NE bedroom.
(by LRIS)

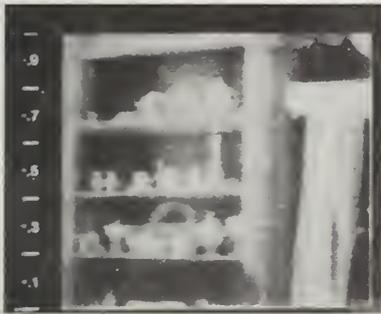
9-1
E wall of
dining room.
(by NBS)

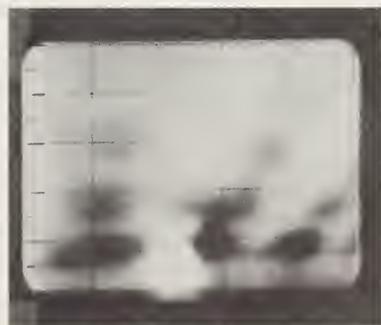
9-9
N pitched ceiling
of NE bedroom.
(by contractor #5)

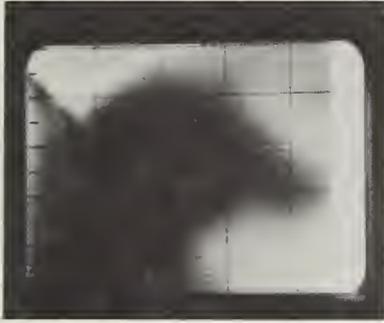
9-10
S pitched ceiling
of SE bedroom.
(by contractor #5)

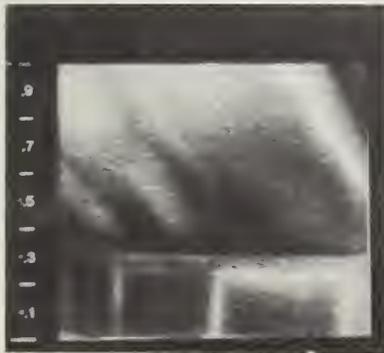
9-12
W pitched ceiling
of NW bedroom.
(by NBS)

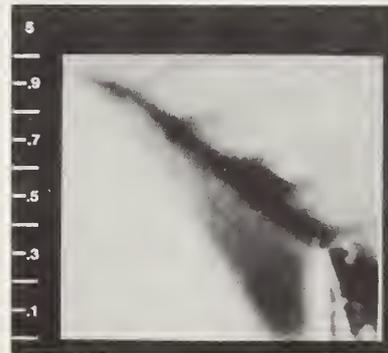
9-13
Above and on
W side of window
of NW bedroom.
(by contractor #6)

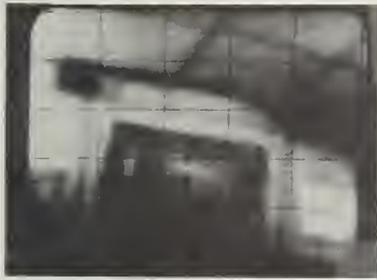
10-1

Above door on E of kitchen. (by contractor #5)

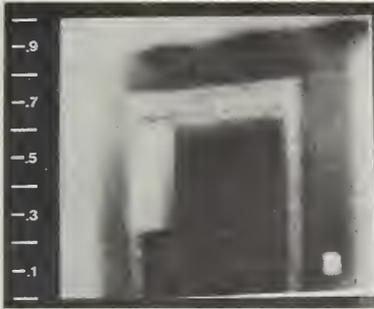
11-1
At top & both
sides of E door
in living room.
(by NBS)

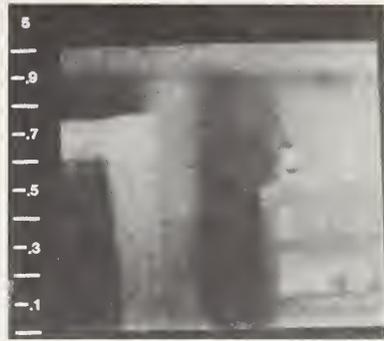
11-3
SE corner on E
of living room.
(by contractor #6)

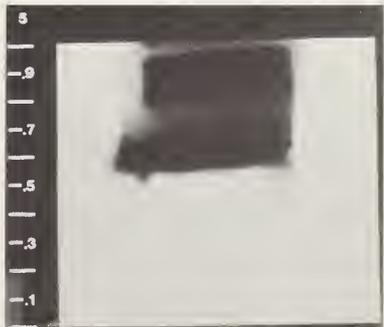
11-9
Underneath S
door in kitchen.
(by contractor #6)

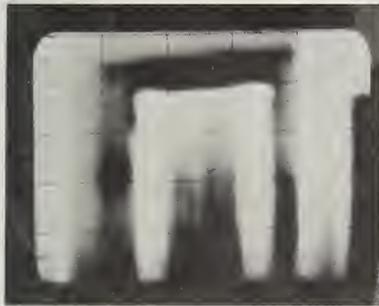
11-10
Around window on
W of NW bedroom.
(by contractor #5)

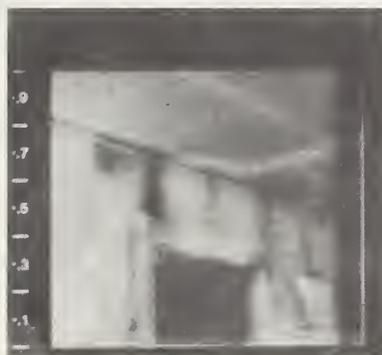
12-2
E wall of
kitchen.
(by NBS)

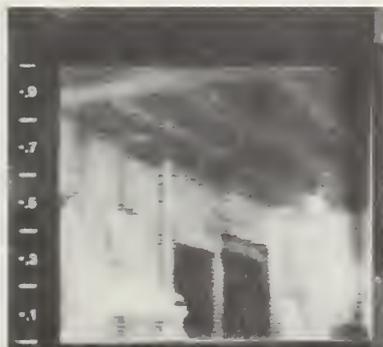
12-3
Cold ceiling on E
of kitchen.
(by NBS)

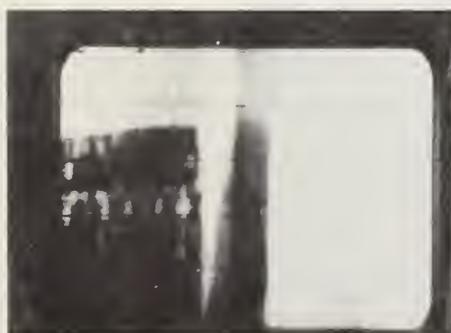
12-5
E wall of
NE bedroom.
(by contractor #5)

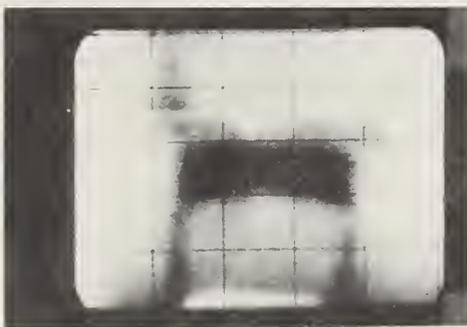
12-7
Above window on
E of S bedroom.
(by contractor #5)

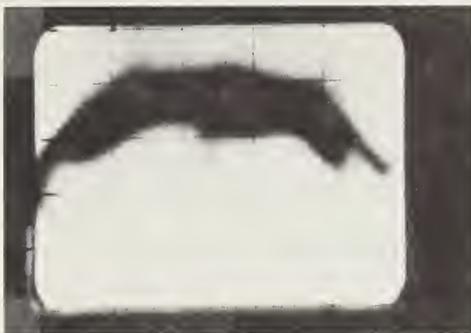
12-8
Below pitched
ceiling on E of
S bedroom.
(by contractor #5)

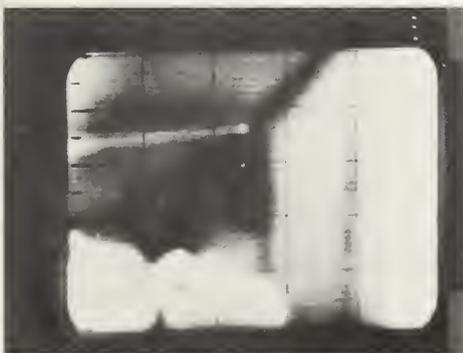
12-9
SE corner of
S bedroom.
(by contractor #5)

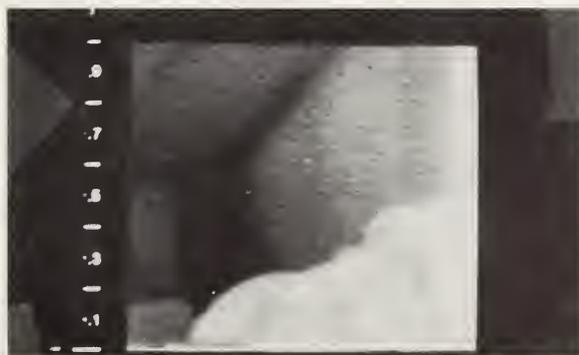
12-11
NE corner of NW
bedroom on 2nd floor.
(by NBS)

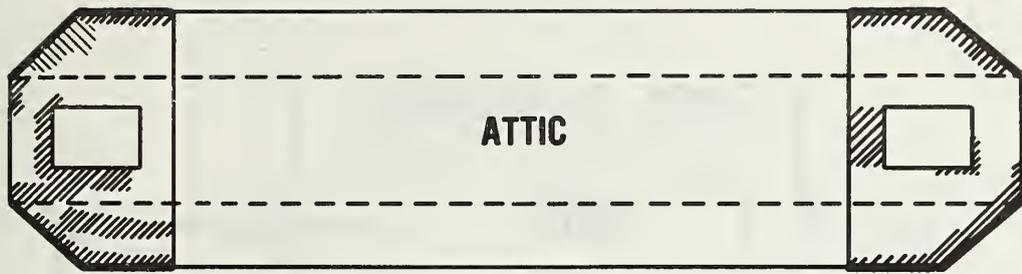
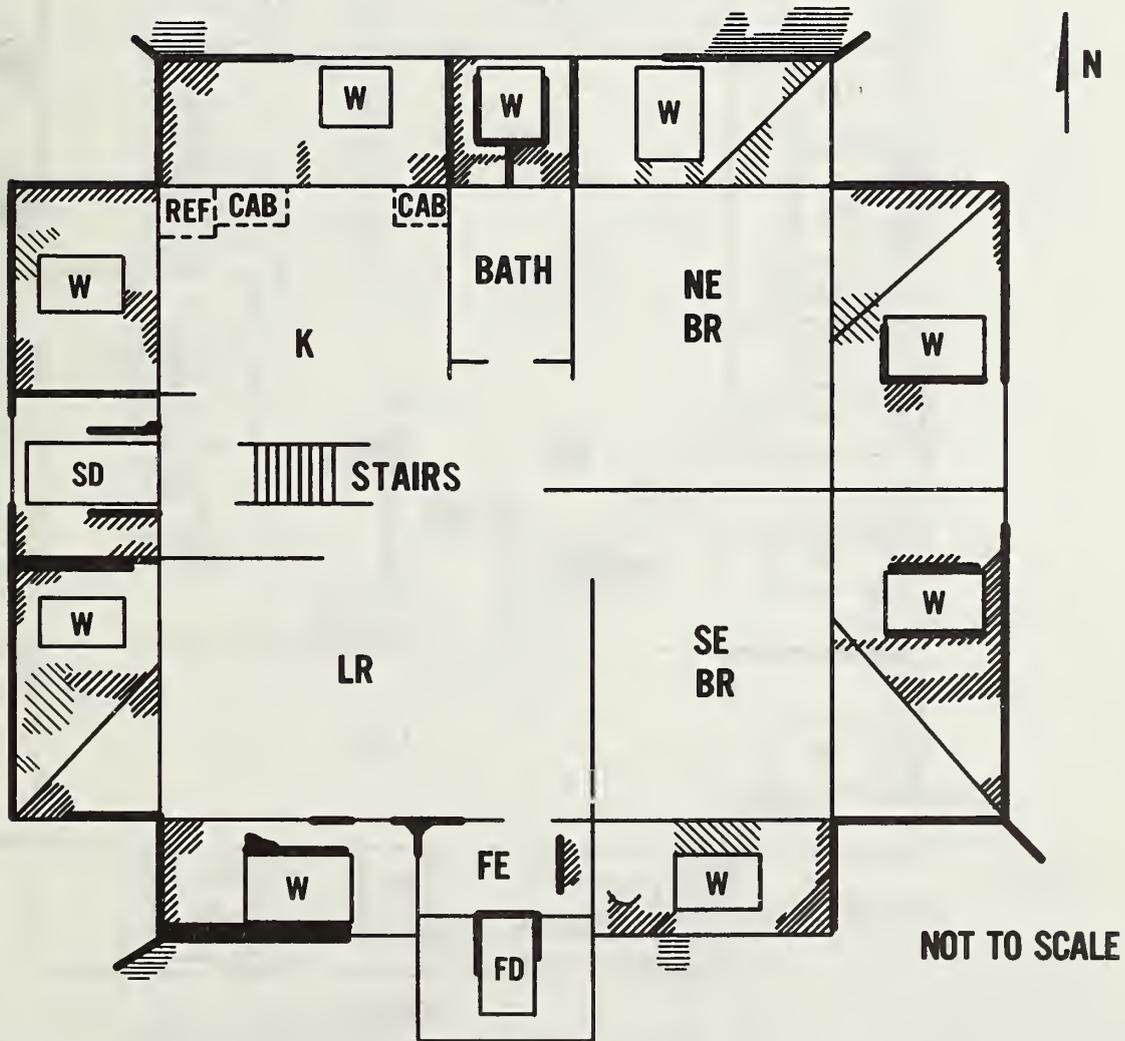
Figure I. Thermal deficiencies observed in Fargo house #1

In general, the most common area of heat loss in this house were found at wall-ceiling joints, at corners (bridges), and also around the diagonal braces. This might be due to the defective sealing at eave junctions such that air leaked into the dwelling. Also, cold ceilings were found at the corners of the south and north sides on the main floor as well as in the attic.

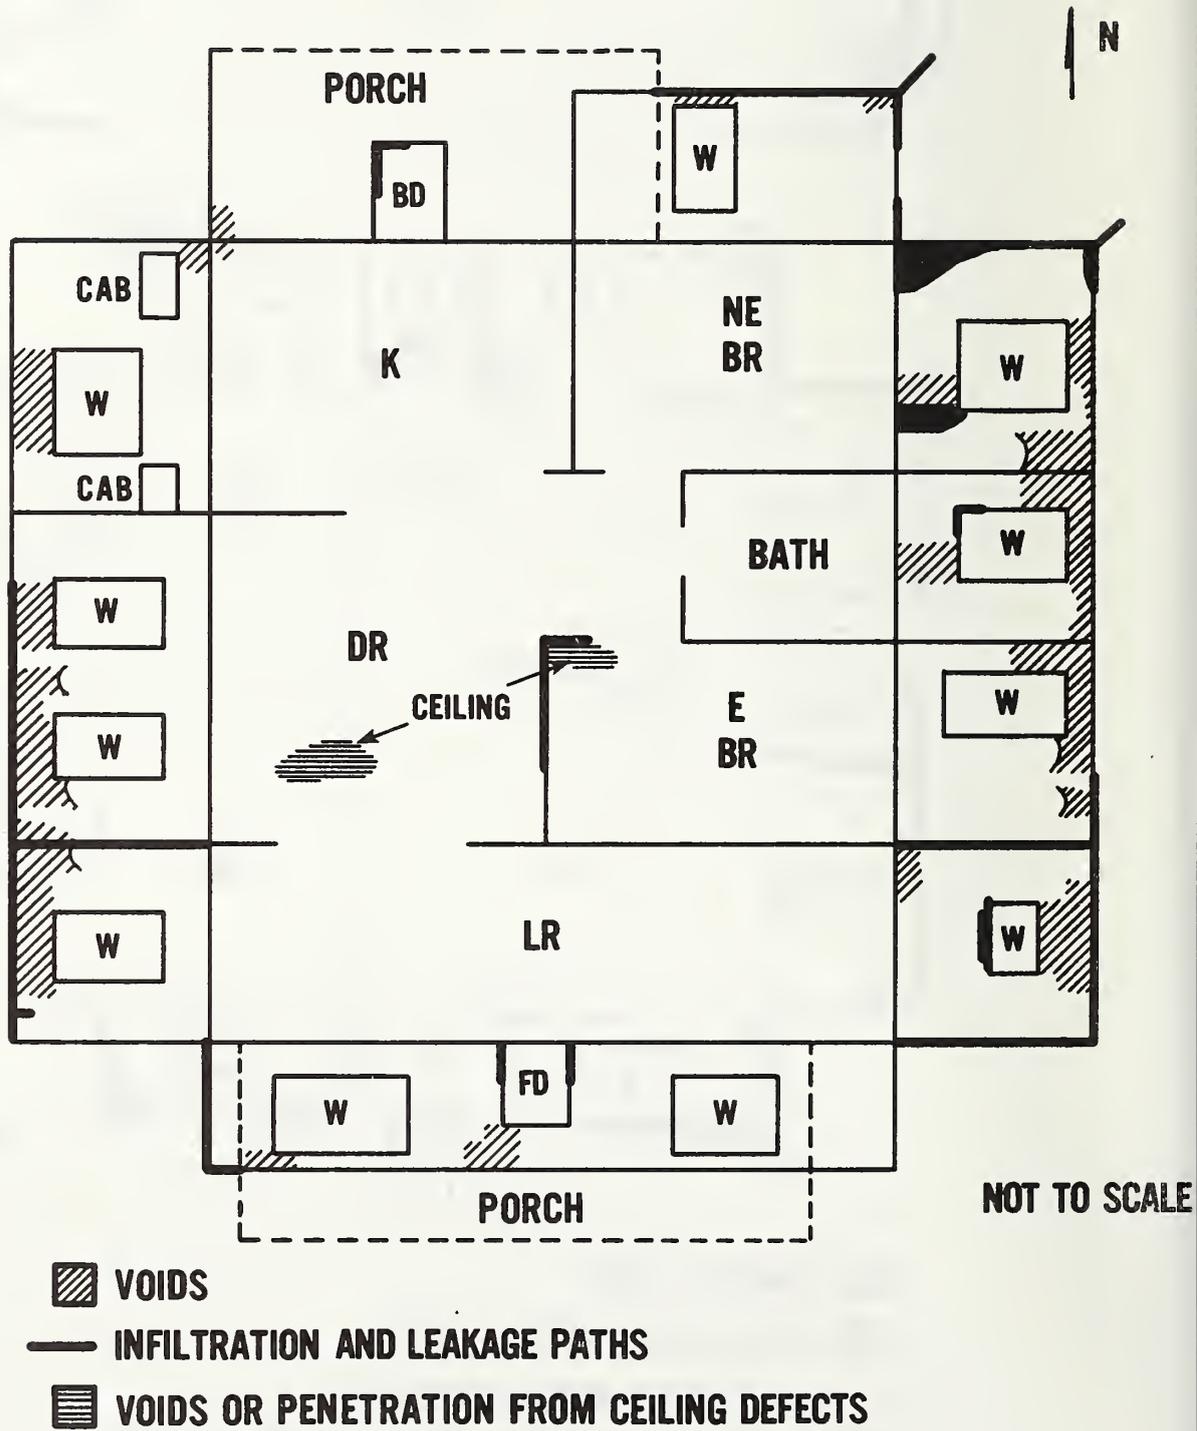
Figure II. Thermal deficiencies observed in Fargo house #2

In general, the most common area showing heat loss in this house were found on both the east and west sides. The voids in these walls may be due to poor installation or extreme shrinkage of foam. The north wall enclosed by the porch was not insulated since insulation was supposed to be added to the outside walls of the house. The outer walls of the porch were not inspected because the porch was not heated. Hence this wall was omitted in area calculations.

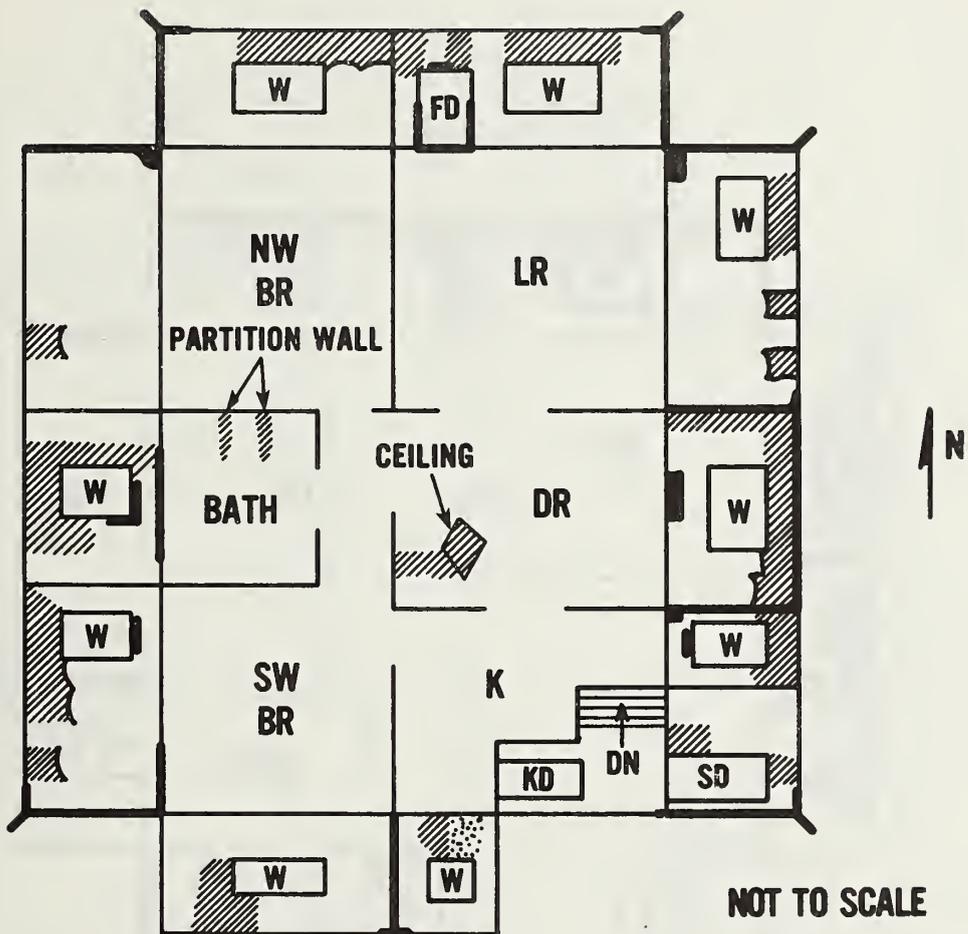
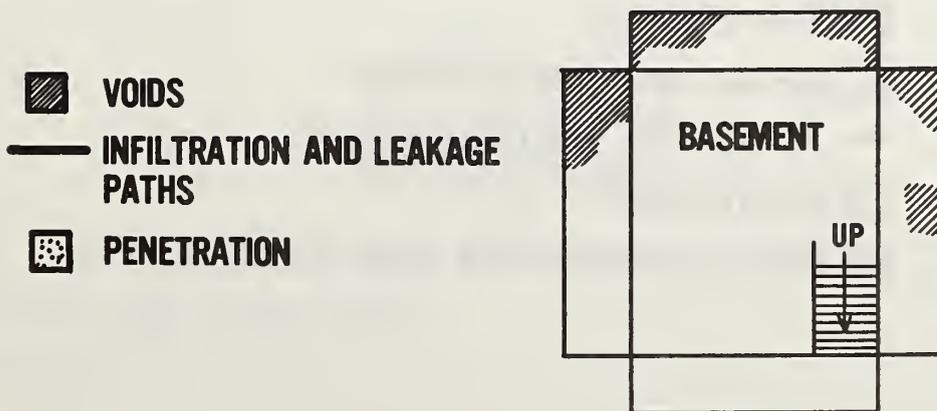
Figure III. Thermal deficiencies observed in Fargo house #3

In general, the most common area of heat loss in this house were found above windows, doors, and eaves as well as air leakage paths below windows.
